# Natural Hazards Vulnerability of the Dominica Hydroelectric Expansion Project

This report documents the findings from the vulnerability to natural hazards audit of the hydroelectric expansion project. The audit included examining actions necessary to reduce vulnerability through both retrofitting and maintenance. This information will be used to establish related costs for reducing vulnerability.

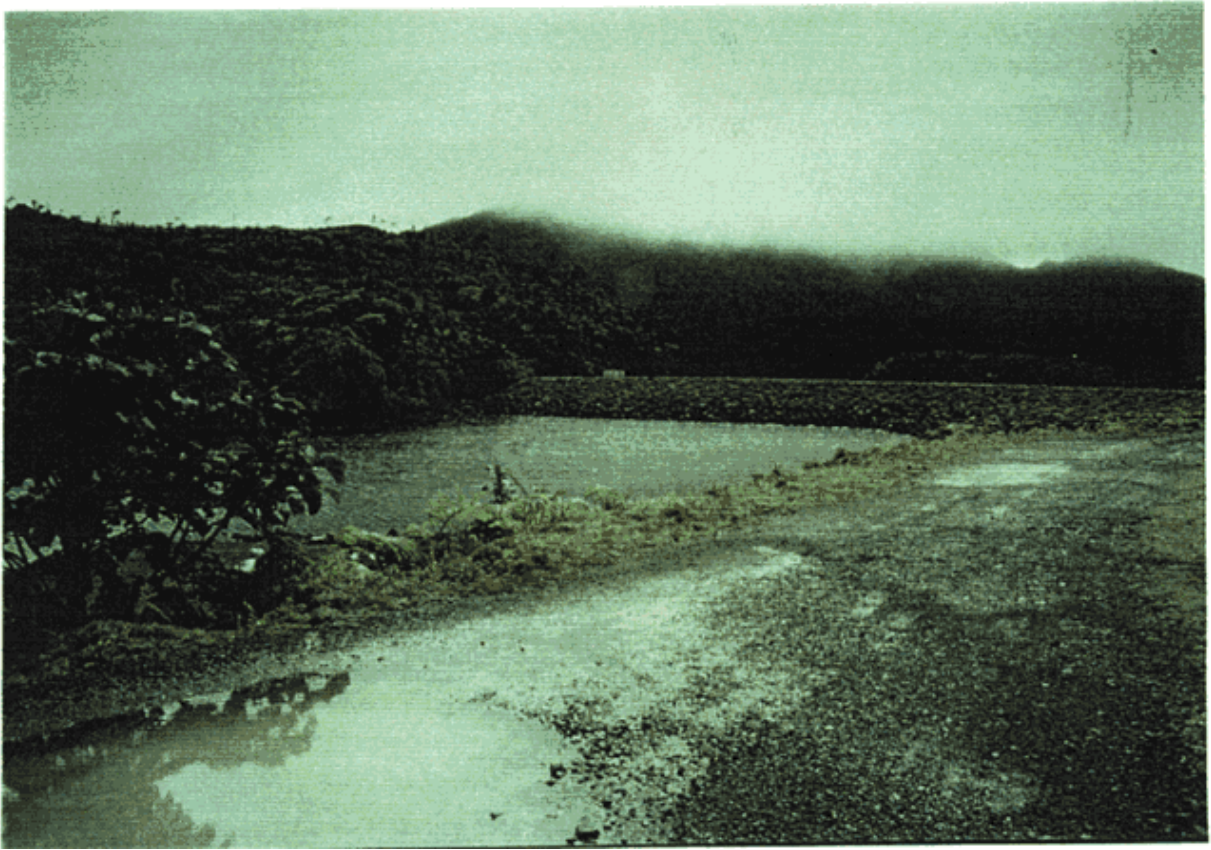
2. rockfill dam - this 10-m high dam raised the level of Fresh Water lake to create a reservoir with a live storage capacity of 500,000 m<sup>3</sup> (Fig. 2).

Figure 2. View of the rockfill dam forming Fresh Water Lake in 1994.

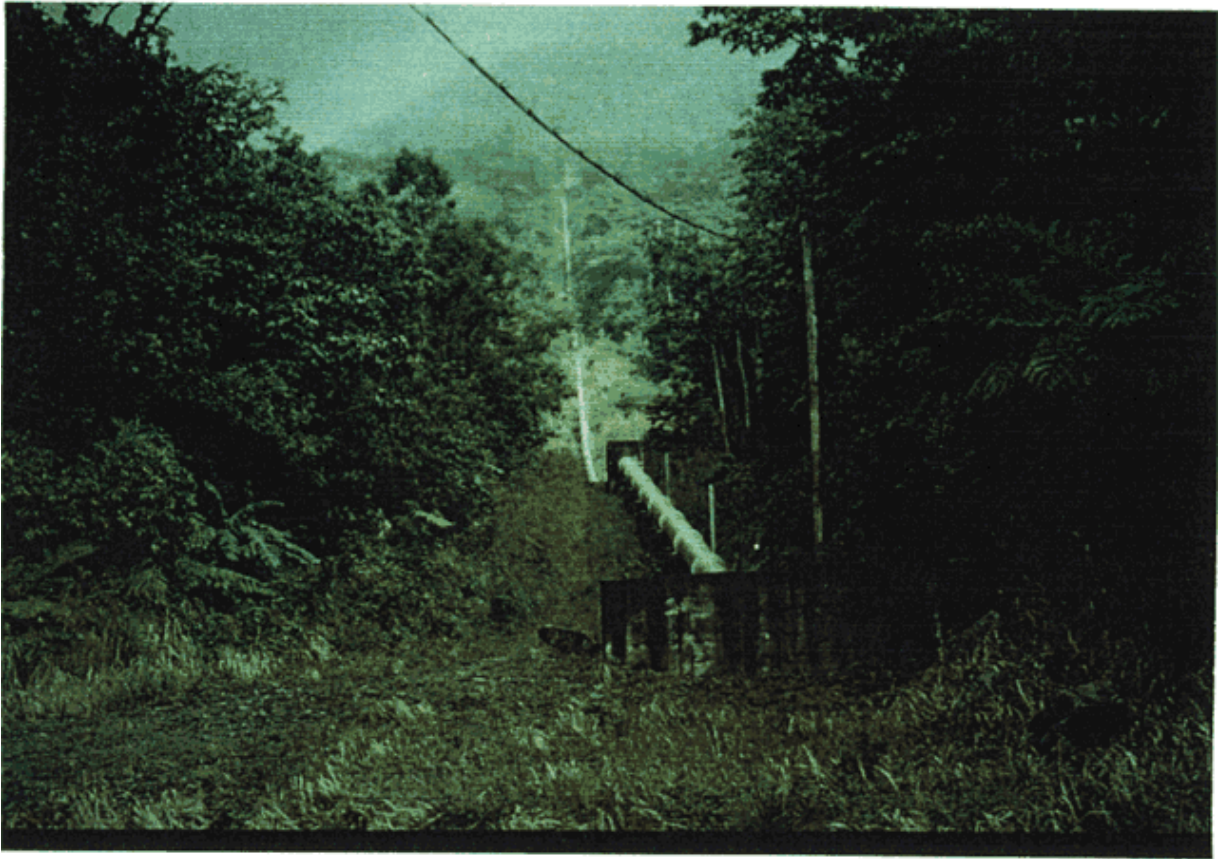
4. pipeline - to convey water from the surge tank to the power station, a 760 mm dia. steel pipeline is used (Fig. 4).
5. power station - the powerhouse is a building which contains a single 1300 kw horizontal axis Pelton turbine and associated control works (Fig. 5).

Figure 4. High pressure pipeline conducting water from the Laudat surge tank (on slope in background) and the powerhouse at Laudat.

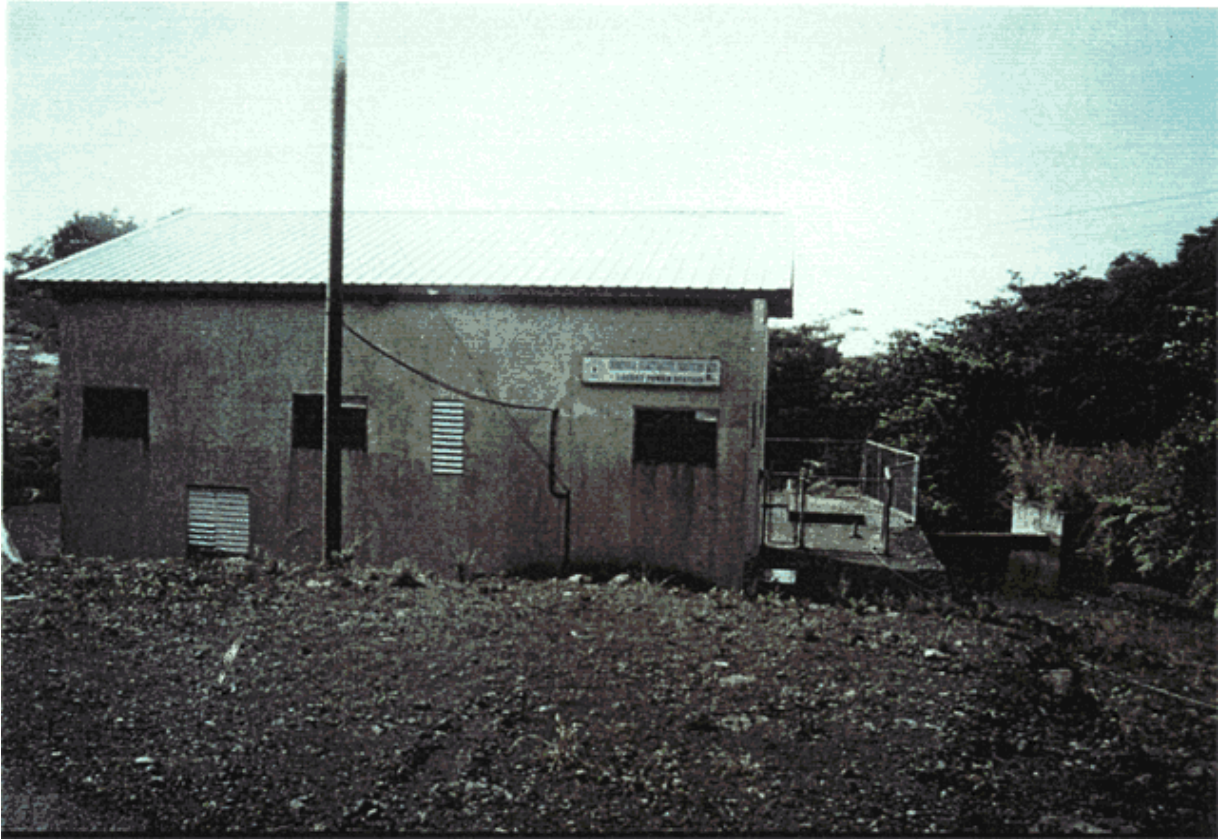
Figure 5. View of Laudat powerhouse. The tailrace is visible to the right side of the building.

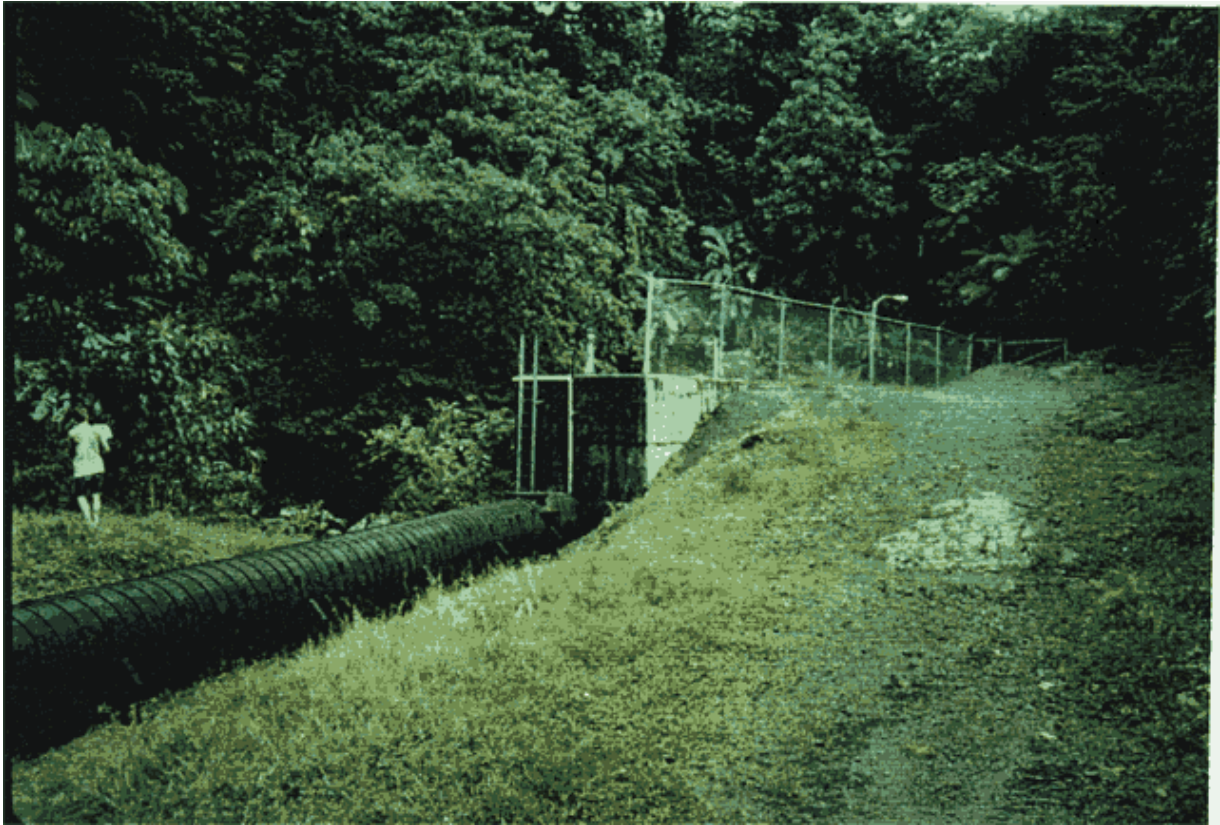
1. diversion weir and intake - a concrete diversion weir at the outlet of Titot Gorge on the Roseau river diverts flow into an intake with a sediment removal tank before entering a pipeline (Fig. 6).
2. pipeline - a 1016 mm dia. woodstave pipeline conveys water from the Titot Gorge diversion to the Trafalgar Balancing tank.
3. diversion weir and intake - another concrete diversion weir is on the stream adjacent to the Laudat power station

Figure 6. View of the Titot intake structure and woodstave pipeline which conducts water to New Trafalgar Balancing Tank. Titot Gorge is located immediately upstream from the location.

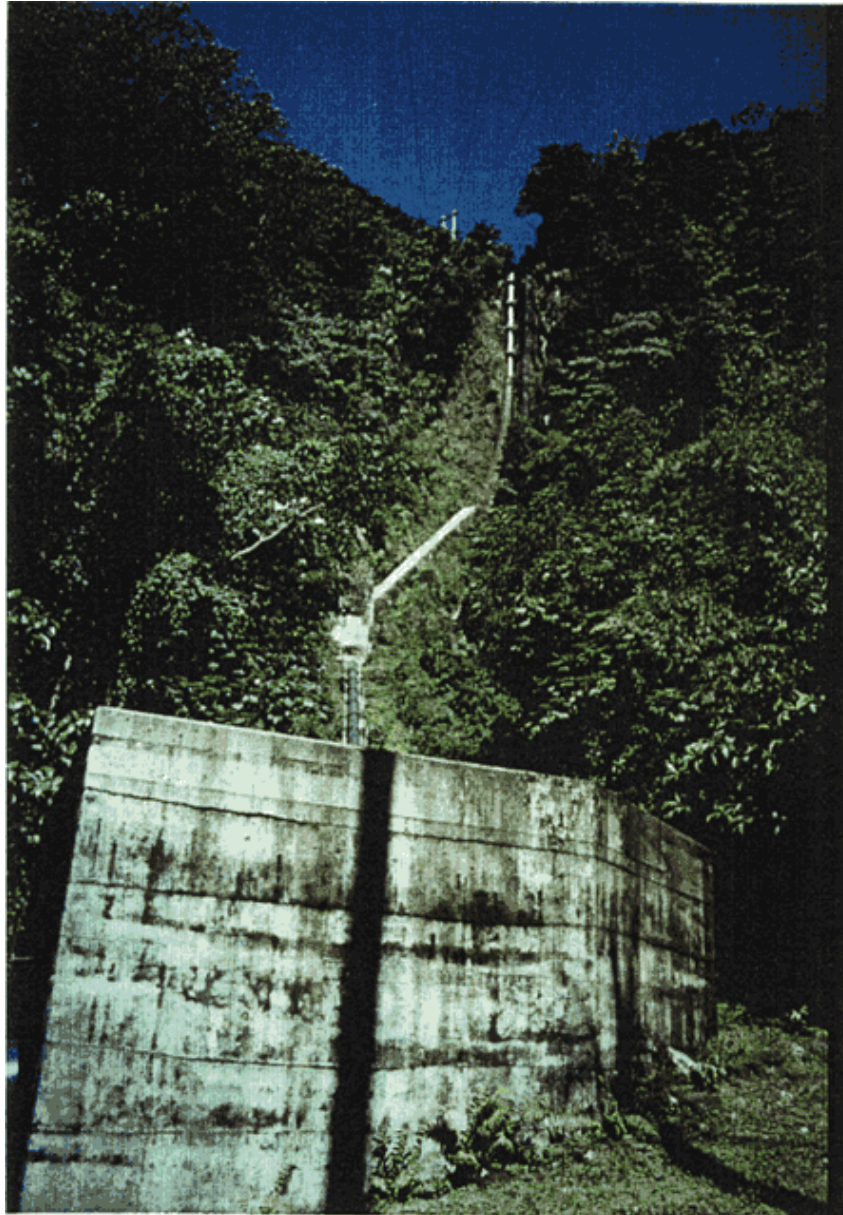
6. pipelines - a 1016 mm dia. pipeline comprised of both woodstave and steel sections conveys water from the balancing tank to the top of Trafalgar cliff. There a 914 mm dia. steel pipeline passes the water down the Trafalgar cliff and feeds into both the existing and new Trafalgar power stations (Fig. 7).

Figure 7. View of Trafalgar Cliff. The high pressure pipeline is visible in the background and leads to the intake structure in the foreground.

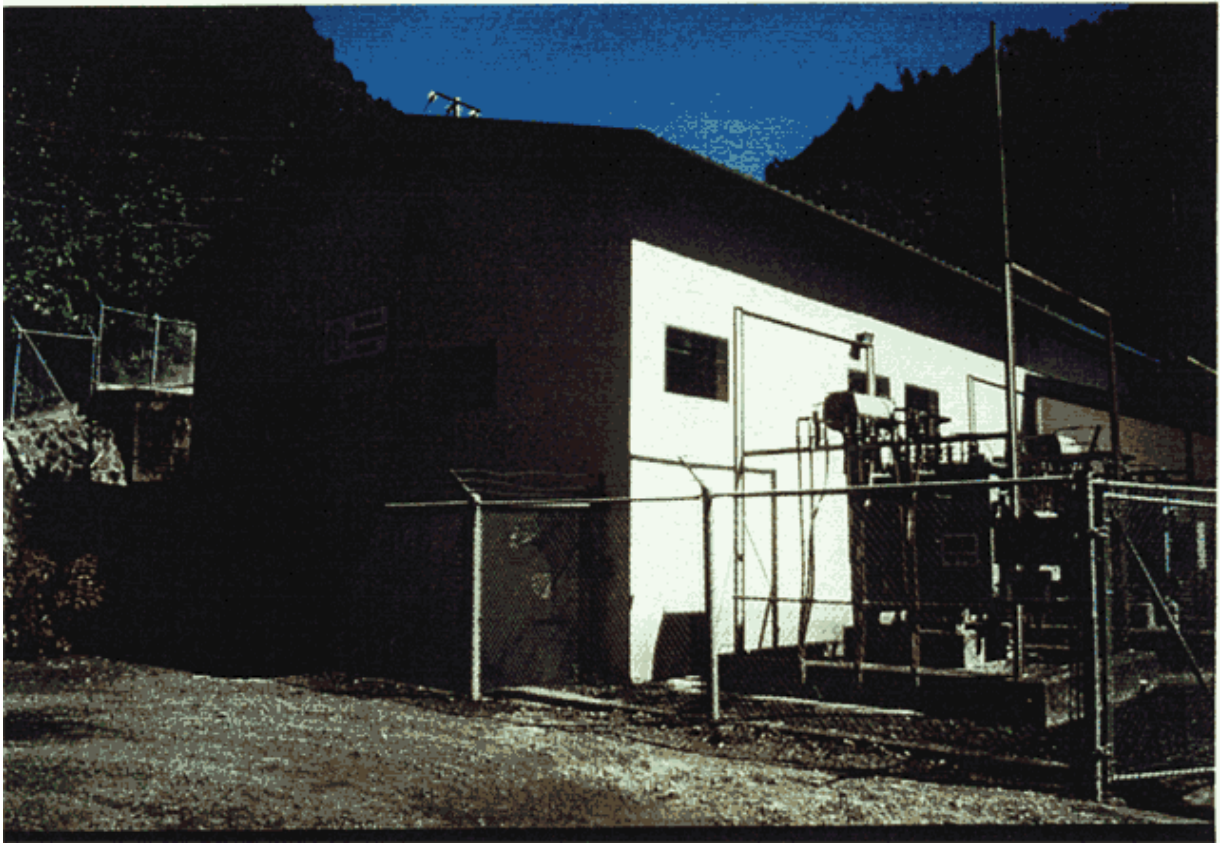
7. power station - the New Trafalgar power station contains two 1700 kw horizontal axis Pelton turbines with associated switchgear. The building housing these facilities also houses a control room (Fig. 8).

Figure 8. View of the New Trafalgar powerhouse.

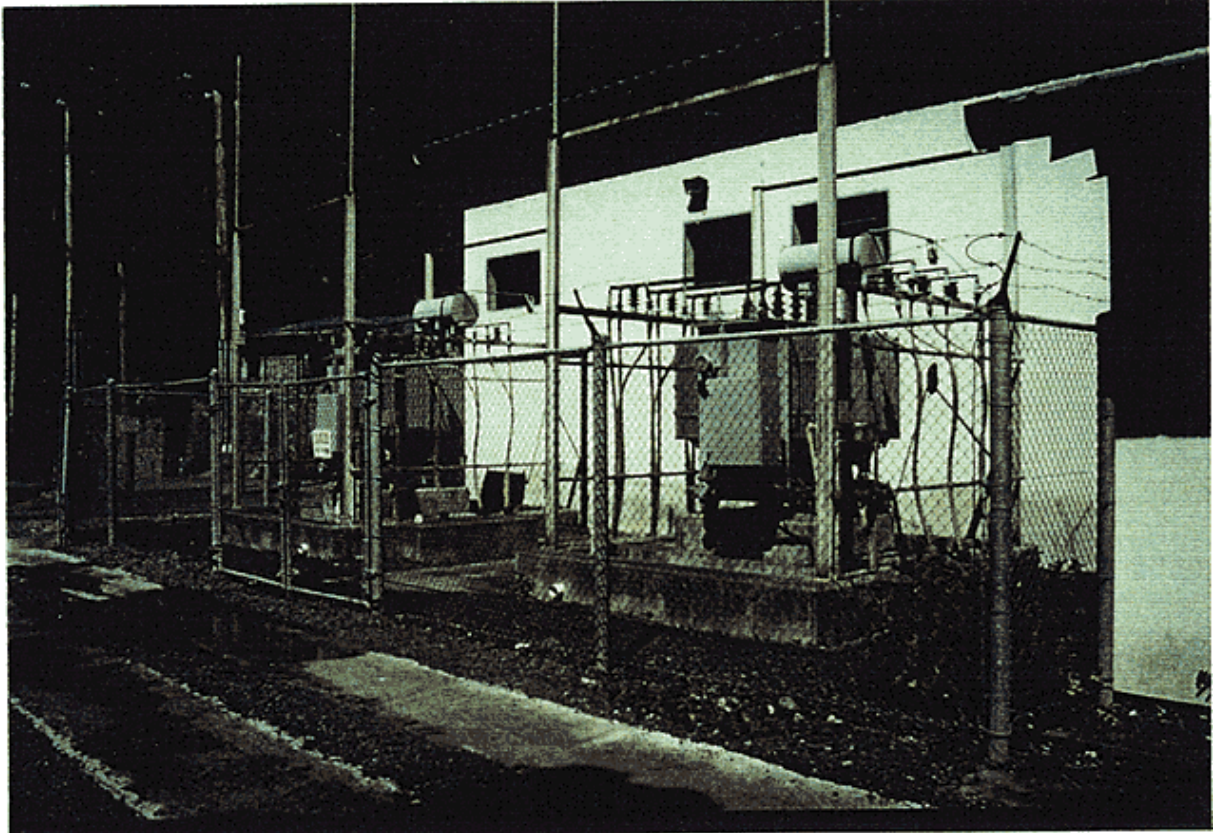
9. switchyard - adjacent to the New Trafalgar power station is a switchyard with two transformers to step up the voltage from 2.2 kV to 11 kV and a short length of overhead cable connecting it to the existing transmission network (Fig. 9).

Figure 9. The switchyard facilities at the New Trafalgar powerhouse.
